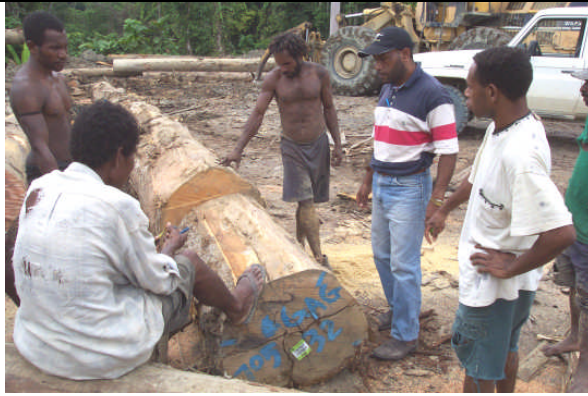
Plate 1 Second trimming at transit log pond/yard.

This photo shows the PNGFA Regional Inspector (Momase) discussing the reasons for trimming the log at the transit yard, with the log scaler (seated at left of photo).

The log has already been trimmed and scaled at the log landing in the set-up and has an official log tag on it.

The double handling of such logs increases the incidence of degrade (in this case splitting) and thus increases the waste of what would otherwise be sound timber.

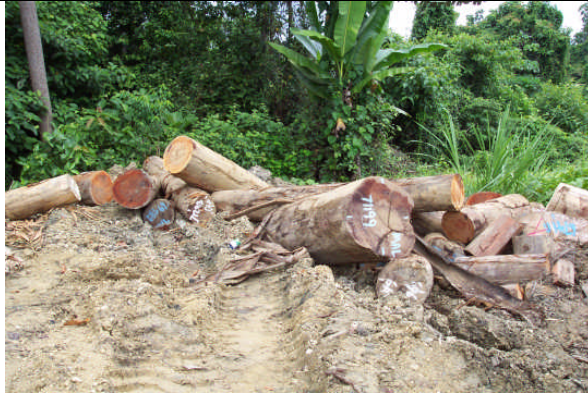
Plate 2 Second trimming off cuts ready for burning.

A pile of off cuts trimmed at the transit yard ready for burning in Block 4B.

This brings into question the veracity of measurements that are noted in the FD66 documents for royalty purposes and the SGS records.

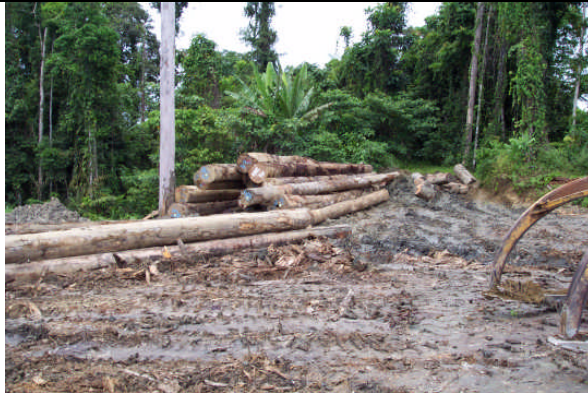
Plate 3 A pile of reject logs at the transit yard.

The same transit yard showing piles of reject mixed white species which will eventually be transported to the log pond at Vanimo and burned.

Vanimo Forest Products Ltd mainly processes kwila, (*Intsia bijuga*) in the sawmill as the company claims there is no market for the mixed white species and the wood rapidly deteriorates.

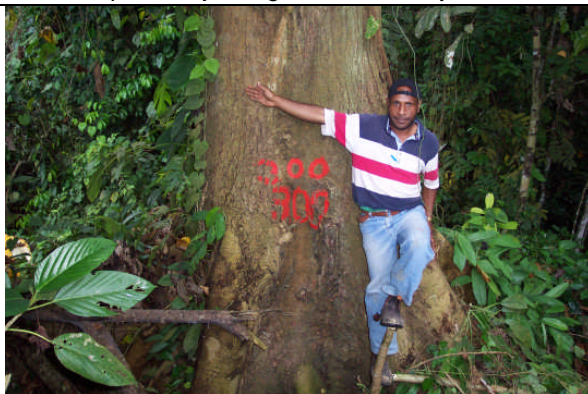
Plate 4 A twenty-year-old Erima tree.

A 20-year-old erima tree (*Octomeles sumatrana*) in a research plot established in 1984.

The area in which the plot was established contained many trees of commercial size and was virtually clear felled during the selective logging operation.

Regeneration was profuse and was tended by officers and labourers from the Vanimo Forestry Station until the canopy had closed.

The tree is 117 cm dbh at age 20 years.

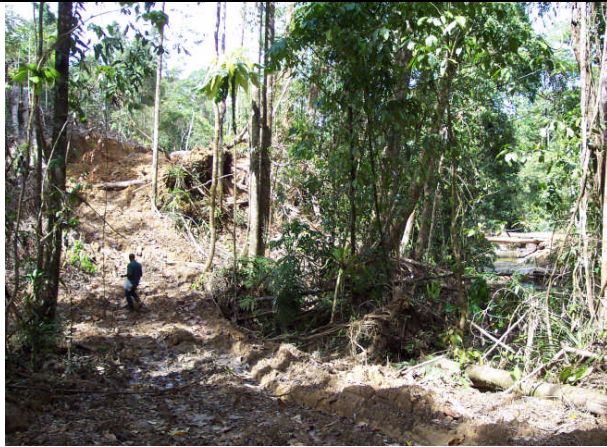
Plate 5 Breach of Key Standard 2 Buffer Zone Class 1 Stream.

This photo shows a skid track traversing the buffer zone of a Class 1 stream.

Tributary streams to this major water way (photo not shown) were blocked by the skid track causing ponding upstream of the snig track.

← The arrow points to the waterway and the bridge across this Class 1 stream.

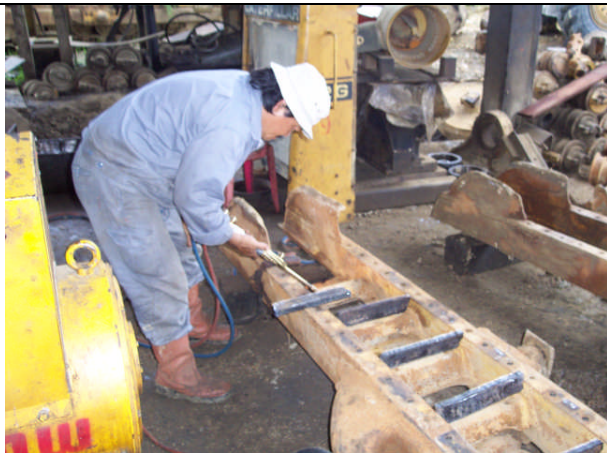
Plate 6 Absence of safety equipment – expatriate employee.

These two photos illustrate the lack of protective equipment being used by both expatriate and local employees of Vanimo Forest Products Ltd.

←Welding with no protective glasses.

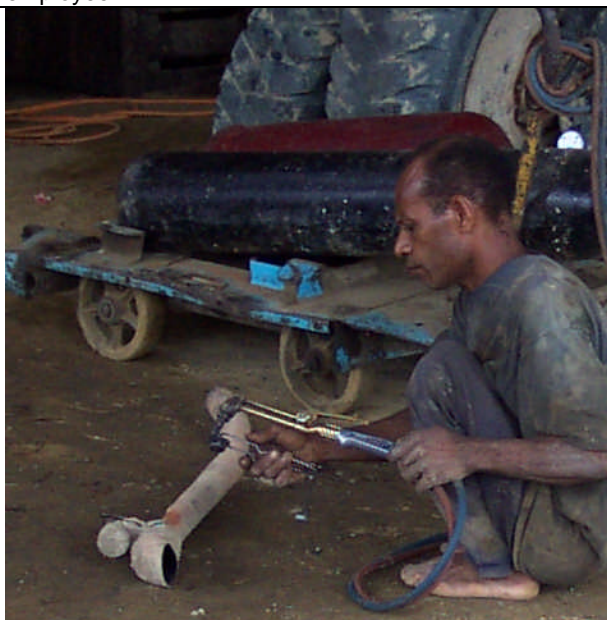
Plate 7 Absence of safety equipment – local employee.

← Welding with no protective glasses.

← No protective boots.

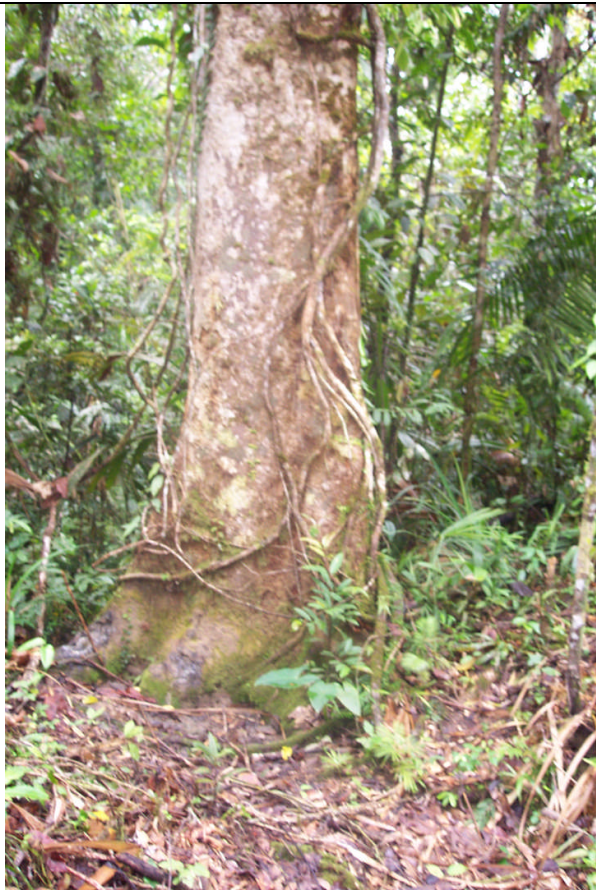
Plate 8 Vines not cut during set-up preparation.

Block 2, Set-up 18, vines not cut prior to application for set-up approval. Breach of Key Standard No. 5.

Vines should be cut well in advance of felling to increase safety for the chainsaw operator and reduce damage to residual trees.

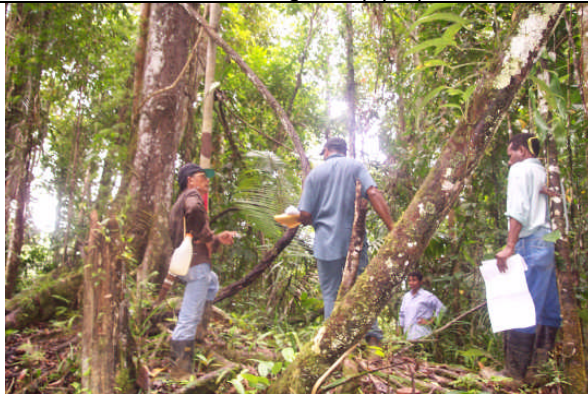
Plate 9 PNGFA Regional Inspector discussing set-up marking procedures with VFP staff.

This photo shows the PNGFA Regional Inspector discussing set-up marking procedures with Vanimo Forest Products survey officers (an expatriate and national) and the PNGFA Project Supervisor.

The Review Team found that none of the set-ups that had been prepared for approval to log and inspected by the team, had been prepared adequately according to the PMC Procedures and Key Standards.

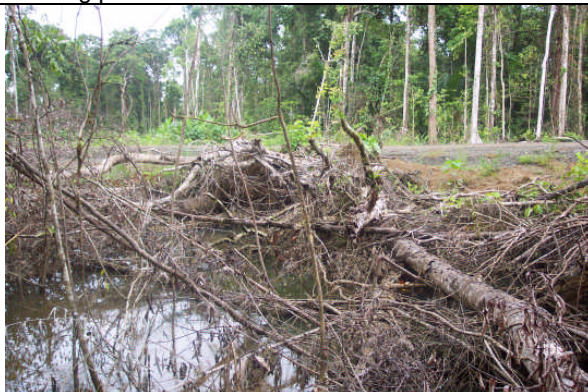
Plate 10 Log clusters used as crossing.

This photo shows a log cluster having been used for a crossing in set-up 2, Block 2.

This is in breach of Key Standard No. 13.

This breach was noted in a set-up that had recently been closed by the PNGFA Project Supervisor.
