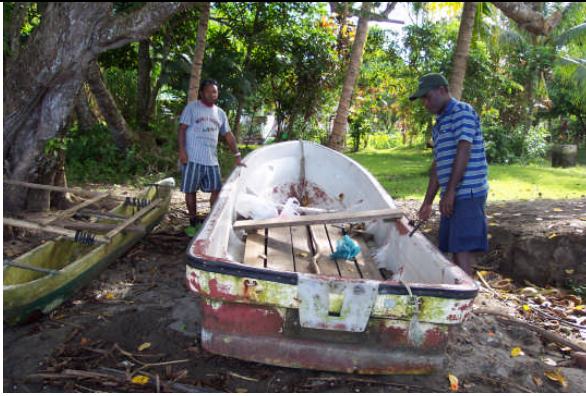
Plate 1 Beginning of journey.

The PNGFA dinghy for access to Seraji is a 19 ft banana boat. The 50 HP outboard motor was out of service due to contaminated fuel, resulting in an estimate of K15,000 for repair.

The Review Team therefore used the 30 HP motor which meant the journey took five hours.

The consensus amongst PNGFA officers is that a 23 footer, with a 40 HP motor, combines safety with reliability and a comfortable speed.

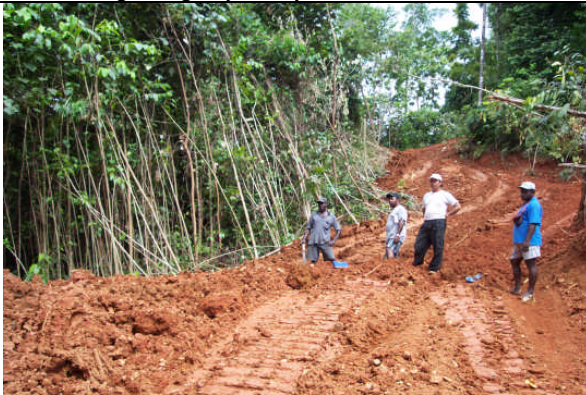
Plate 2 Regrowth indicates previous logging.

This is a skid track in set-ups 10 and 11.

The skidding distance is excessive as the contractor has no planned log landings within the set-up. The amount of soil disturbance is also excessive for a skid track.

The advanced regrowth indicates that the set-up was partially logged two years ago.

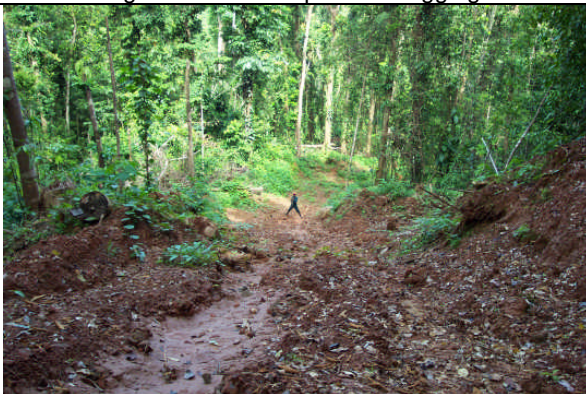
Plate 3 Erosion caused by no water bars.

The slope along this skid track was measured with a clinometer at 25 degrees.

The set-up has been closed but the absence of water bars has created an erosion channel.

Effective water bars, ie small channels to direct water into the forest and away from the skid tracks can be constructed by villagers with spades at very little cost.

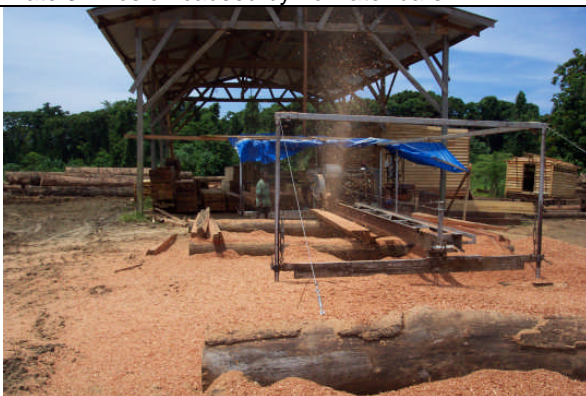
Plate 4 A Forestmil at the log pond.

The wood produced by this mill is some of the best quality sawn timber observed by the Review Team to date (October 2003).

The photo illustrates the potential for reducing waste if a suitable sawmill is located at each log pond.

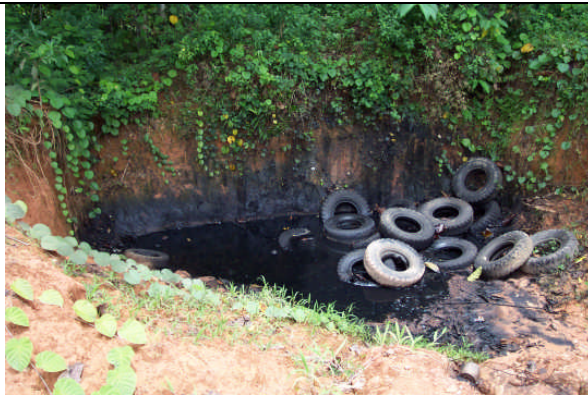
Plate 5 Workshop waste.

This waste pit is located near the workshop on a ridge top with a creek flowing at the bottom of the ridge, approximately 40 metres below.

This presents a risk of pollution to the creek.

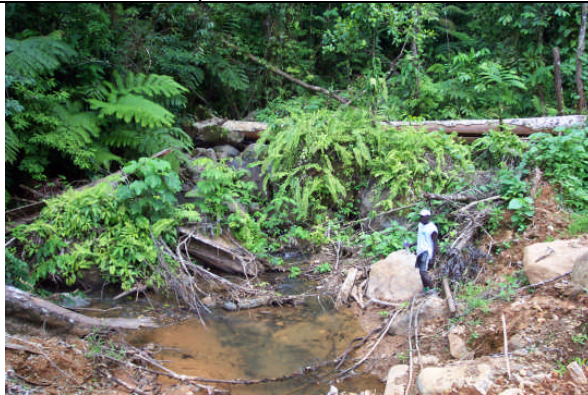
Plate 6 This is a Class 1 watercourse.

This class one watercourse should have a 50 metre buffer zone marked along it.

The buffer was not marked and trees were felled right up and into the watercourse.

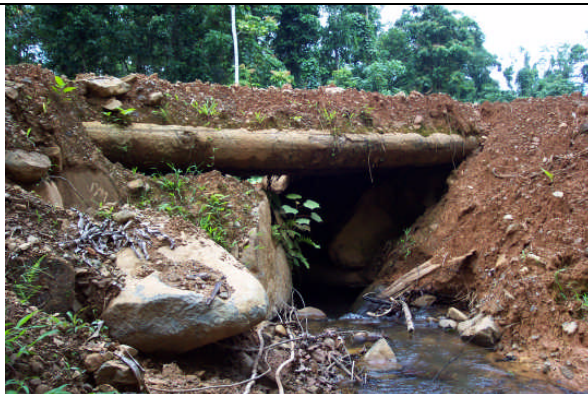
Plate 7 A "graun bris".

← This is the same watercourse looking downstream the bridge construction has narrowed the flow and is the bridge is likely to be washed away at the next flood.

This form of water crossing is often referred to as a "graun bris", meaning a bridge constructed with soil (and a few logs).

This bridge is along the feeder road from Seraji Base Camp to Takis Village.
