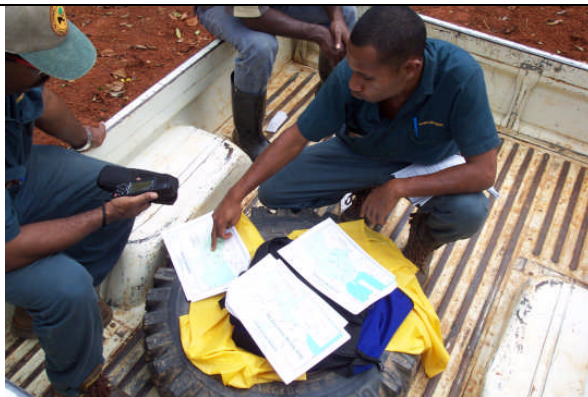
Plate 3. Inspection of Set-up Plans.

This photo shows the PNGFA a/Project Supervisor for Makapa and the Regional Inspector examining set-up plans prior to a field inspection by the Review Team, PNGFA and Innovision (PNG) Ltd.

Apart from the confusion over minimum buffer zone widths, Innovision (PNG) Ltd has excellent set-up planning procedures in place.

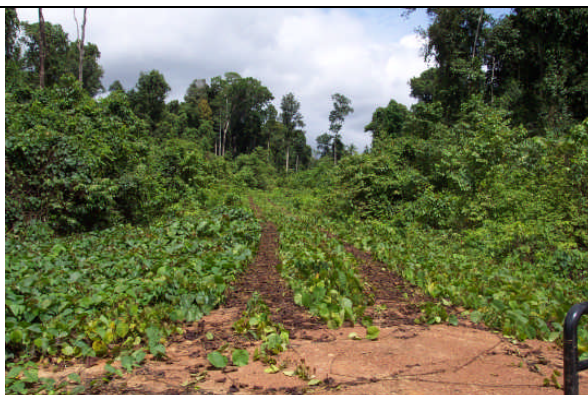
Plate 4. A Non-Decommissioned Road

This is an example of a road, which should have been decommissioned according to the LCOP, but landowners have requested that it remain open for hunting purposes.

This is a reasonable request and has been observed by the Review Team at other project sites.

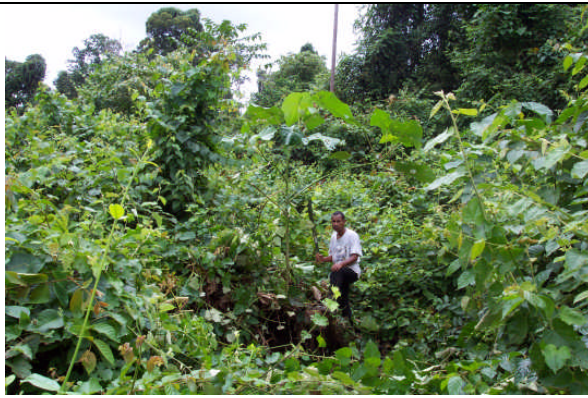
Plate 5. The edge of the same road as in plate 4.

The road carriageway could be left intact for hunting and future access provisions and the edges tended to remove vines that are stifling commercial trees like this erima, (*Octomeles sumatrama*).

These trees grow fast enough to produce a merchantable sized tree within 15-20 years.

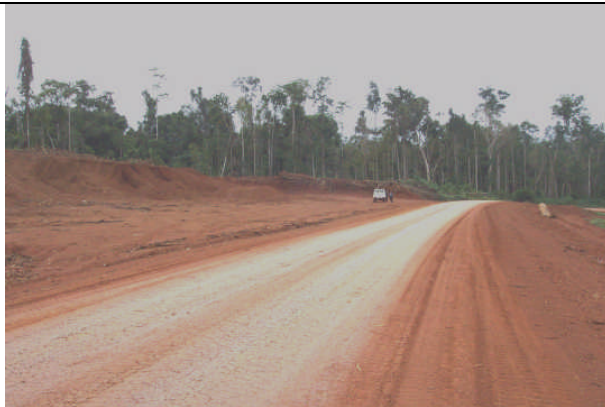
Plate 6. A Gravel Pit along a Main Logging Road.

This vegetative clearance is in excess of the maximum clearance allowed under the LCOP (40 metres) and the excavated area needs to be landscaped and revegetated.

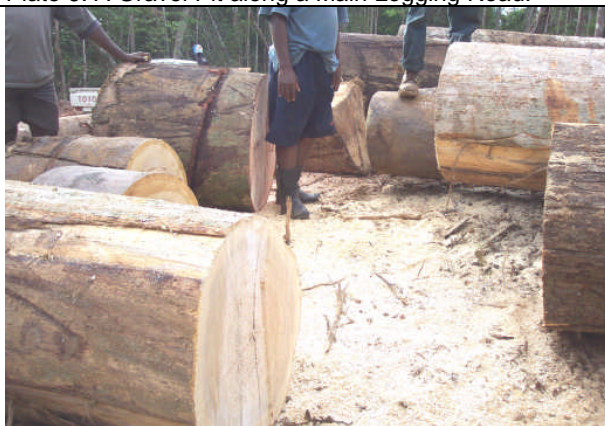
Plate 7. Docking at log landing prior to scaling.

This photo illustrates the excessive docking carried out at log landings. This is done in order to obtain the best grade of log for export.

The photo, along with many others obtained by the Review Team, show that sound wood is being cut off, which could have been used in a sawmill if the docking was carried out in such a manner as to maximise total log volume.

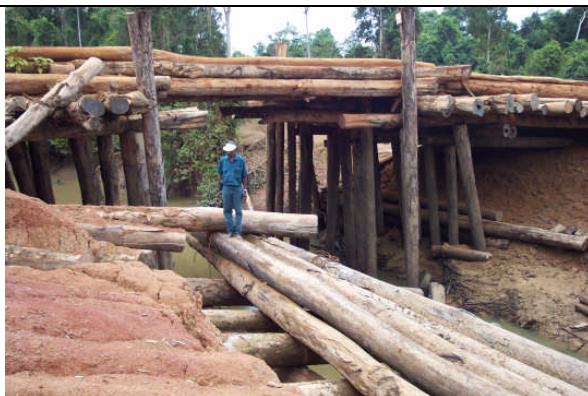
Plate 8. Bridge over the River Gogoroba.

← The new bridge along the main logging road.

← The old bridge structure should be removed to allow for the flow of the river and the riverbanks strengthened to avoid erosion, as required under Key Standards 19 and 20.

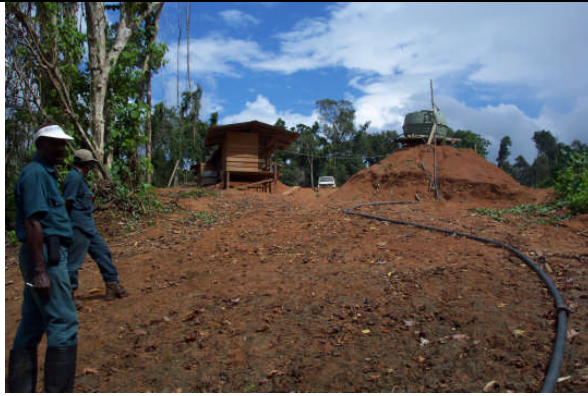
Plate 9. The "Expatriate Transit" camp at "8 Kilo"

This transit camp is part of a proposed barge site at "8 Kilo" camp.

The vegetation has been extensively cleared and water is being extracted from the Wavoi River.

The photo shows the "expatriate" compound, which has no proper sewage system.

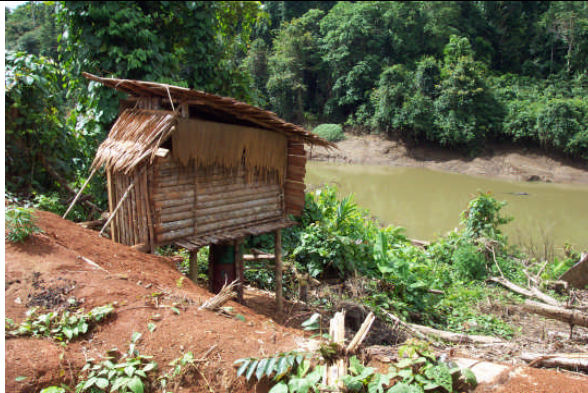
Plate 10. The "Nationals Transit" camp at "8 Kilo".

The photo illustrates vegetative clearance within the buffer zone of the Wavoi River (a Class 1 stream, therefore requiring a minimum buffer width of fifty metres).

The photo also illustrates, inter alia, the standard of toilet provided at the "nationals" camp.

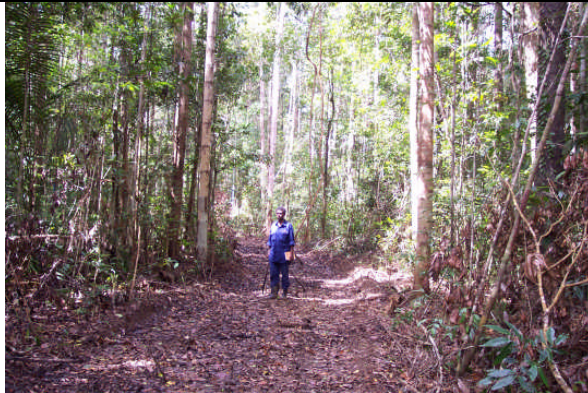
Plate 11. An example of a snig track in a logged set-up.

Logging within set-ups is generally done very well and in strict adherence to the LCOP.

This photo shows a snig track in a logged over set-up.

The residual stand has been left virtually undamaged.

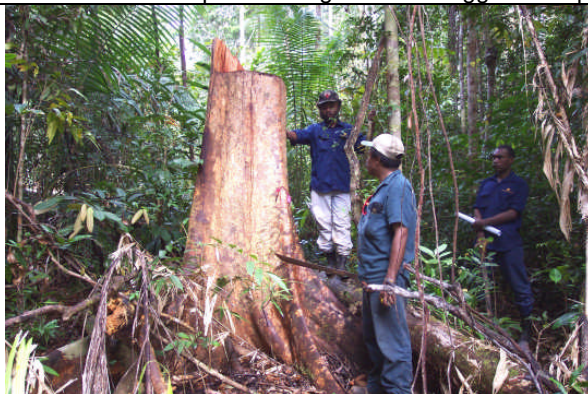
Plate 12. Unnecessary waste during felling.

This photo shows a further example of unnecessary waste.

Bad felling technique has left over a metre of sound wood above the buttress of this tree.
