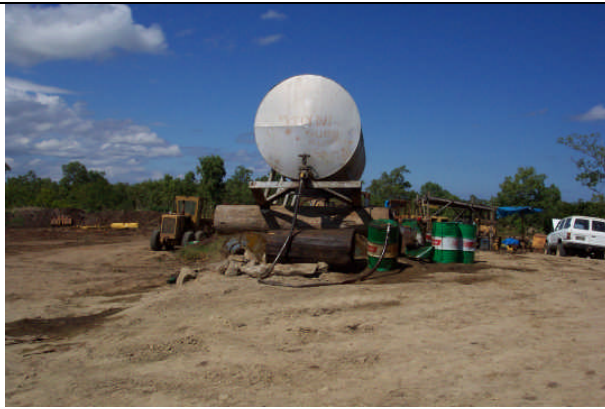
Plate 1. Fuel Storage Kara Log Pond

Portable Fuel Tank at Kara Log Pond located about 15 metres from the living quarters.

Does not have bund constructed around it (Key standard 24) and is not located in a secure lockable area. (Ref EP approval conditions 17 (iii)).

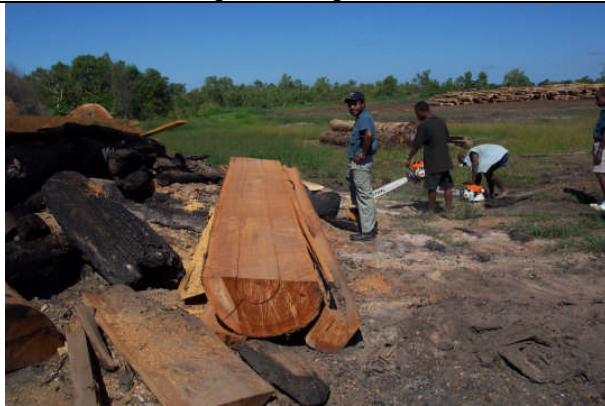
Plate 2. Reject Pencil Cedar Kara Log Pond

This reject pencil cedar log is destined to be burnt after a few slabs had been cut using a chainsaw mill.

A small sawmill such a Lewis Mill would have been able to utilise much more of this valuable timber.

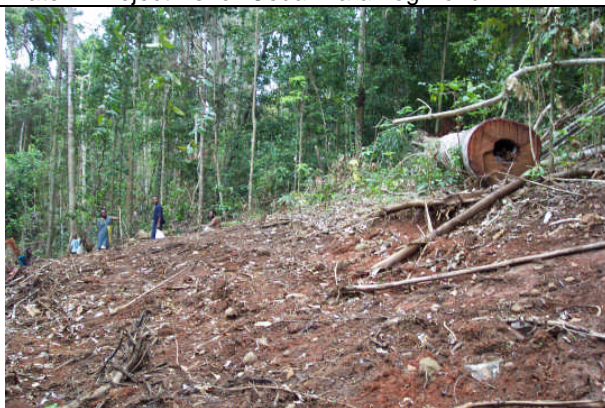
Plate 3. Reject Log adjacent to large gap

A large gap caused by the felling of several commercial trees concentrated in this area. This is a normal situation and will require the use of the "Reforestation Naturally" Technique to assist in satisfactory regeneration of commercial species.

The large defective log (Kempas) has contributed to the size of the gap. Could this defect have been discovered prior to felling?

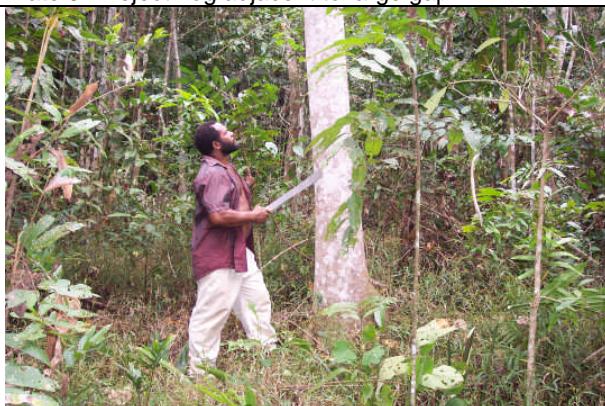
Plate 4. Macaranga and Trema spp dominate regeneration

This photo was taken in Coupe 03 logged in 1997, where Mersawa (*Anisoptera polyandra*) was the main commercial species.

The regeneration of commercial species is shaded by non-commercial species, which causes the commercial species to grow slowly.

This poses a question for sustainability of timber harvesting and supports the findings of the Cameron/Vigus report on the status of Natural Regeneration in PNG (1993).

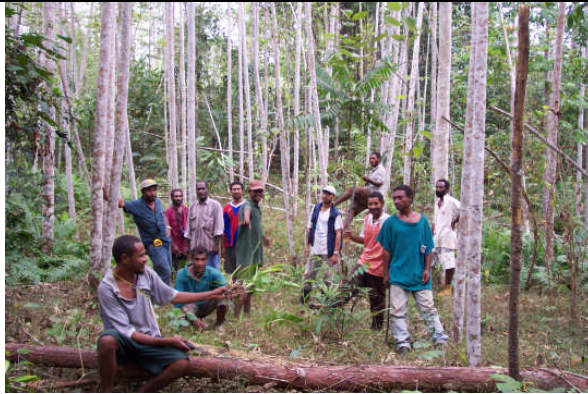
Plate 5. Regrowth of *Macaranga* spp and *Trema* spp after fire

This photo was taken in Coupe 02 logged in 1996.

The area was burned during the 1997/8 El nino event. This has resulted in an almost pure crop of *Macaranga* spp with some *Trema* spp.

Commercial tree species are regenerating but growing very slowly under the canopy of the non-commercial tree species.

This area is suitable for agriforestry, agriculture and plantation forestry.

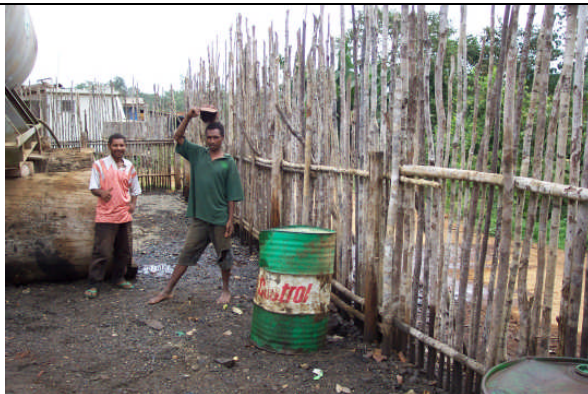
Plate 6. Fuel Storage at Base Camp

This is another case of incorrect fuel storage, with no bunds constructed to confine the spillage of fuel oil which is spreading out along a path and unless corrected will eventually leak into a nearby watercourse.

← Note fuel oil spillage outside of wooden fence.

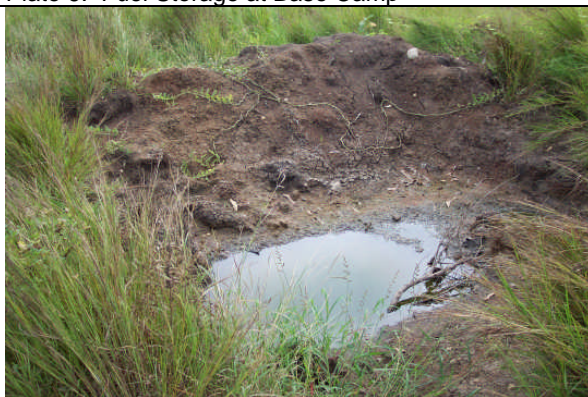
Plate 7. Open Pit at Kara Log Pond used for waste oil

This shallow pit is used by the company to dispose of waste sump oil etc.

These waste oils should be stored in containers and disposed of after clearance from DEC.

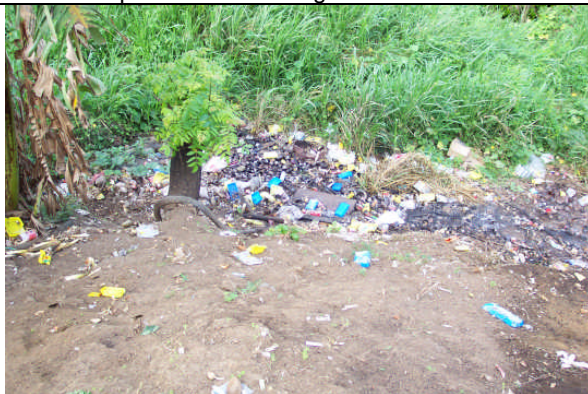
Plate 8. Domestic waste/rubbish disposal Kara Log Pond

This “dump” is adjacent to the living quarters at the Kara Log Pond.

This is unsanitary. Household rubbish should be stored in waterproof containers (eg plastic rubbish bags) and disposed of in an approved pit.
