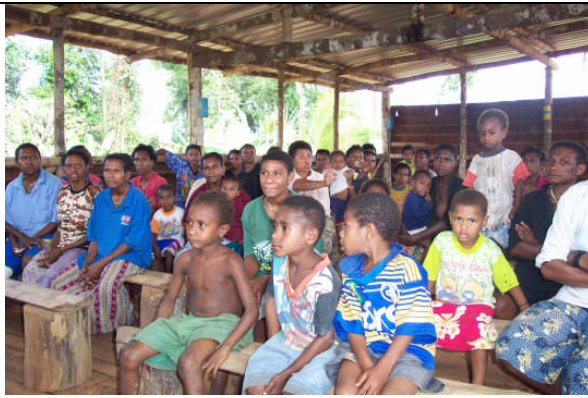
Plate 1. Women and Children meet with the Review Team.

Meetings were held at Sasereme Base Camp between the Review Team and landowners who have settled there as a result of the establishment of the base camp.

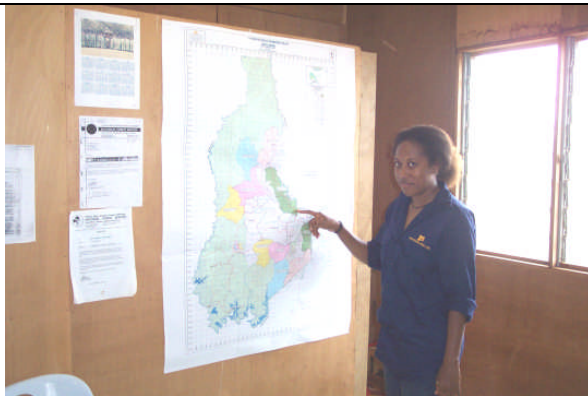
Plate 2. Planning for Logging Operations.

Planning for logging operations by Innovision (PNG) Ltd in the office at Sasereme.

Innovision (PNG) Ltd has employed seven Papua New Guinean forestry graduates, including two females.
